## CASE STUDY

### Use of Log Erosion Barriers (LEBs) for Slope Stabilisation and Post-Fire Ecosystem Recovery in a Mediterranean Forest Ecosystem (Italy)

**Project acronym:** NbS4LD

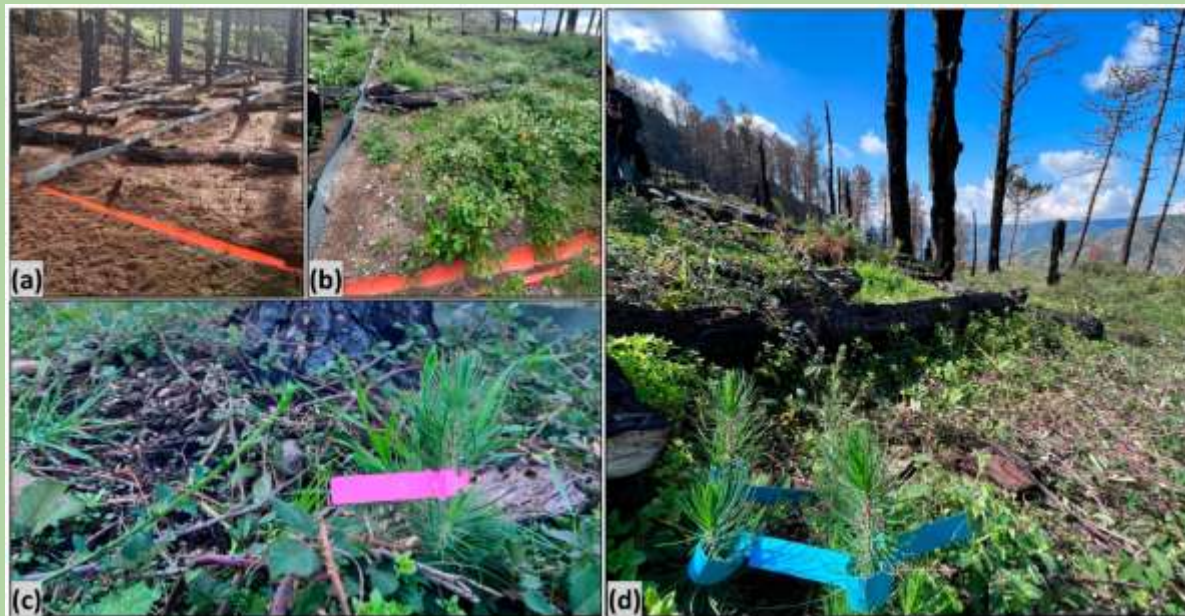
[View of (a) newly installed log barrier subplot, (b) pioneer plants growing above the logs after a few months, (c) young pine seedlings, and (d) spreading vegetation cover - Source: MDPI]

The installation of burnt logs along contour lines created sediment accumulation zones (5–15 cm thick) upslope of the barriers, effectively interrupting runoff pathways and reducing the development of rills compared to untreated areas. This led to a 20–30% reduction in soil erosion, increased soil moisture retention in depositional areas, and early vegetation regrowth concentrated near the logs. Untreated slopes continued to experience active erosion and sediment transport, demonstrating that the intervention effectively supported natural regeneration and slope stabilization.
