## CASE STUDY

### The Almonaster post-fire restoration (Spain)

**Project acronym:** NbS4LD

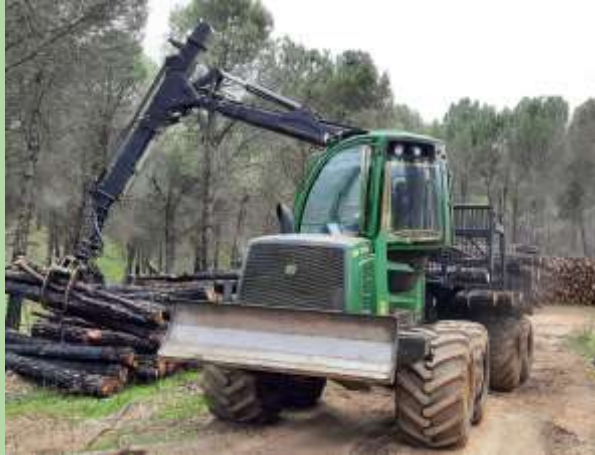
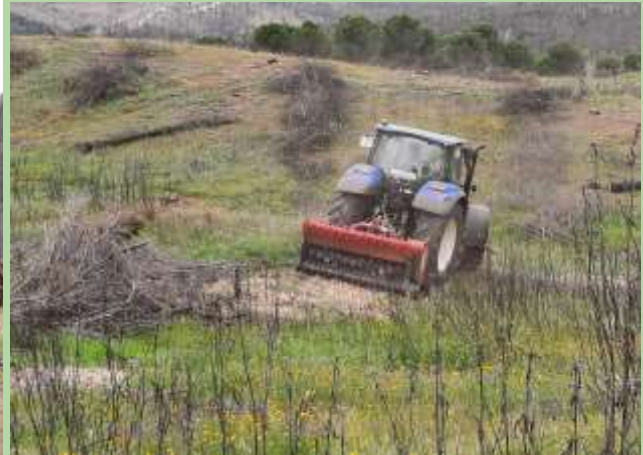
[Burned tree collection (left) and removal of biomass residues (right) - Source: GTA Ingenieria]

Burned trees were selectively removed to reduce safety risks and pest propagation. Biomass from burned trees is shredded and applied as organic mulch to improve soil organic matter and promote natural regeneration. Subsoiling along contour lines is also used to improve infiltration in areas lacking vegetation. These practices are designed to rapidly stabilize soils, prevent sediment transport to reservoirs, and create suitable conditions for vegetation recovery and reforestation after severe wildfire disturbance. The intervention followed adaptive management principles commonly applied in post-fire ecosystem restoration.

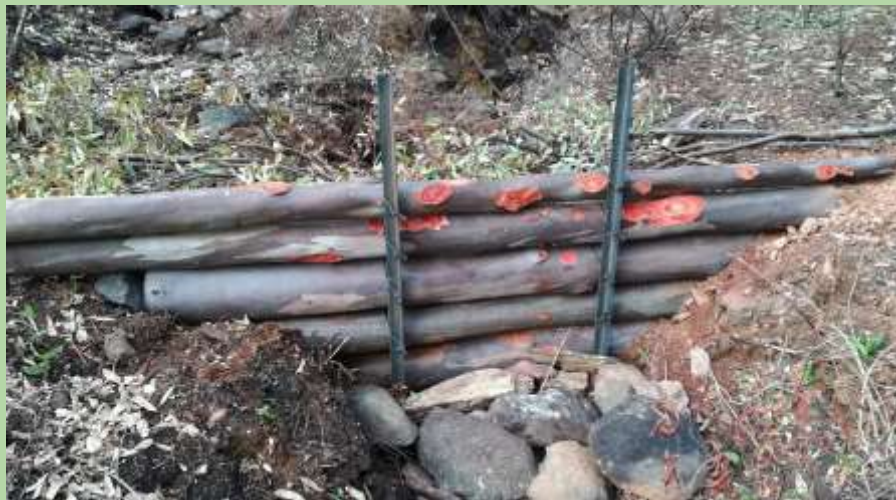
[Eucalyptus-made check dam (albarrada) - Source: GTA Ingenieria]

The Almonaster post-fire restoration program consists of the deployment of hydrotechnical soil conservation structures and targeted forestry management actions. Fajinas (contour barriers) made from burned eucalyptus and pine trunks are installed along hillslopes to reduce runoff velocity and trap sediments, while albarradas (check dams) are placed in drainage channels to slow water flow and minimize gully erosion.

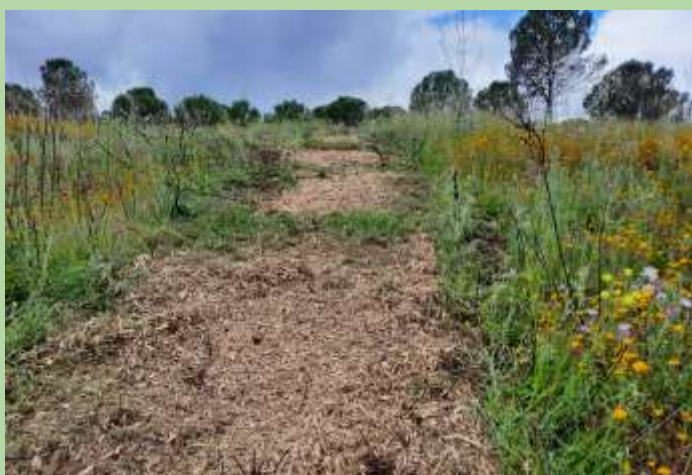
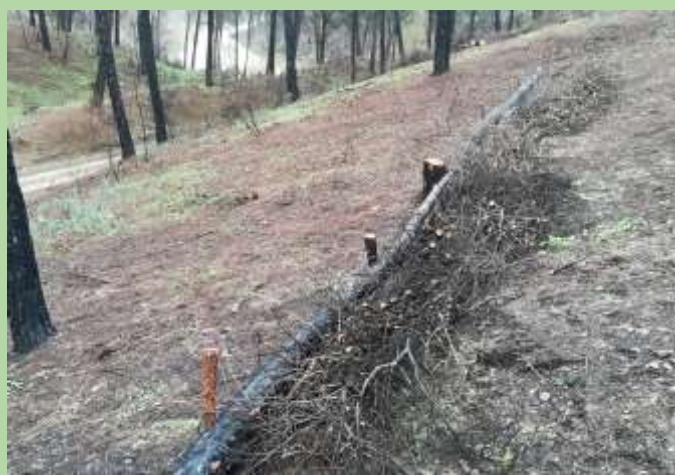
[Shredded biomass residues. Pine-made contour barrier (fajina) - Source: GTA Ingenieria]

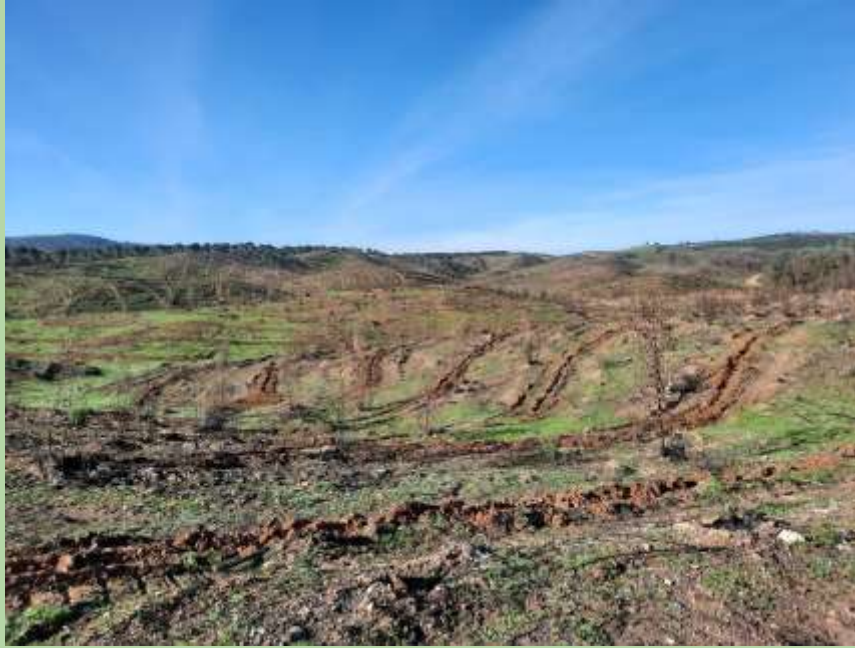
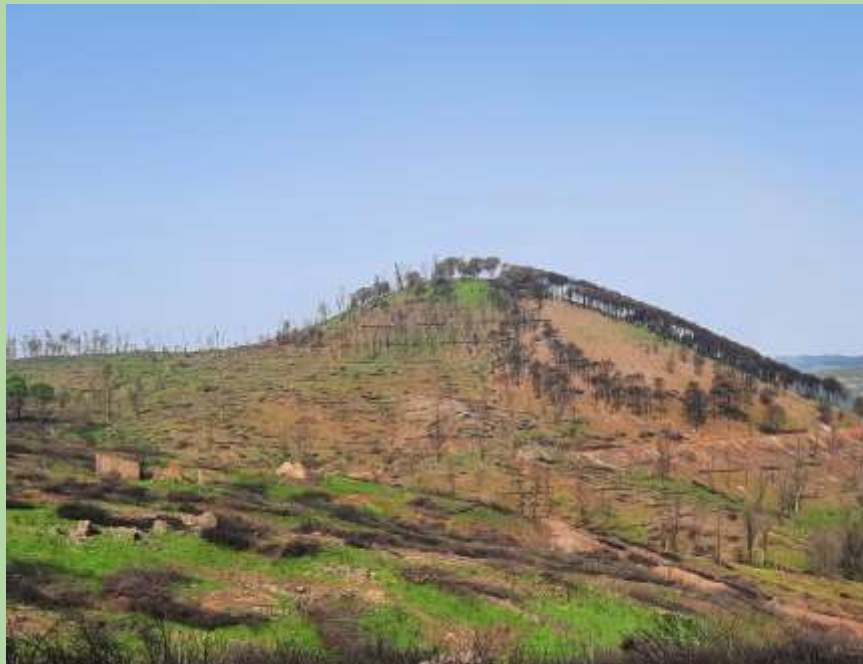
[Subsoiling - Source: GTA Ingenieria]

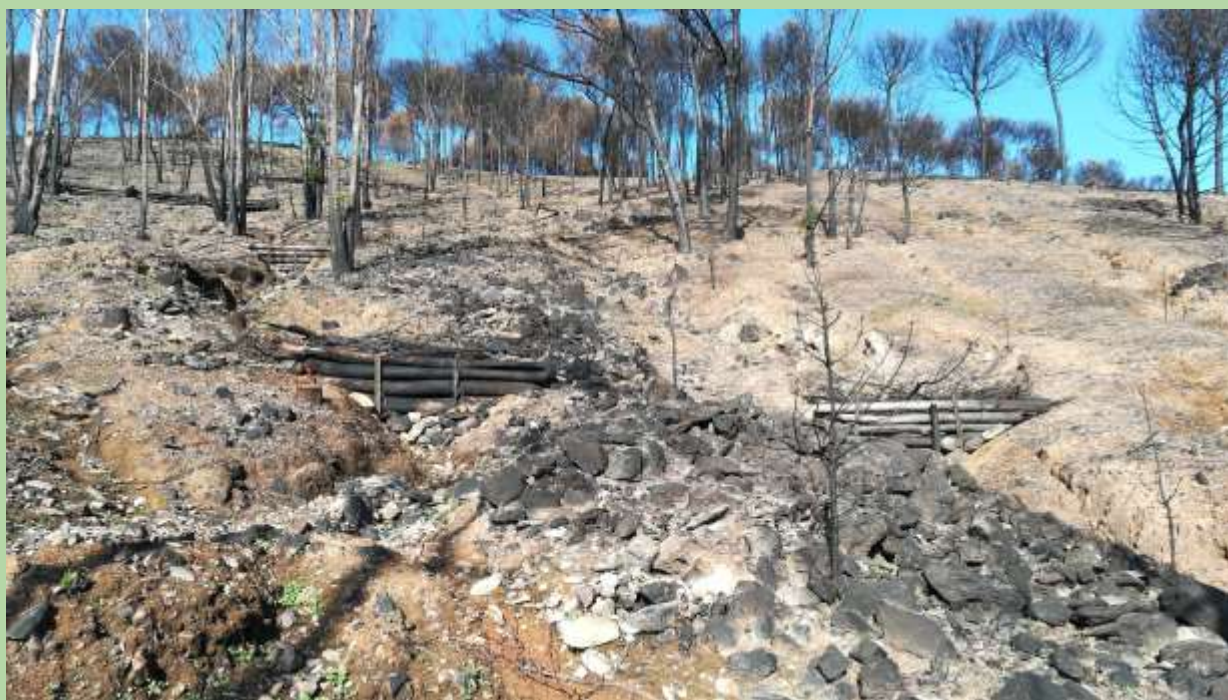
[Check dams (albarradas) on hill slopes - Source: GTA Ingenieria]
