## CASE STUDY

### Disaster Response and Recovery After the Bozkurt Flood in Kastamonu (Turkey)

**Project full title:** Enhancing Technical and Vocational Skills for Implementing Nature-Based Solutions (NbS) to Combat Land Degradation

**Project acronym:** NbS4LD

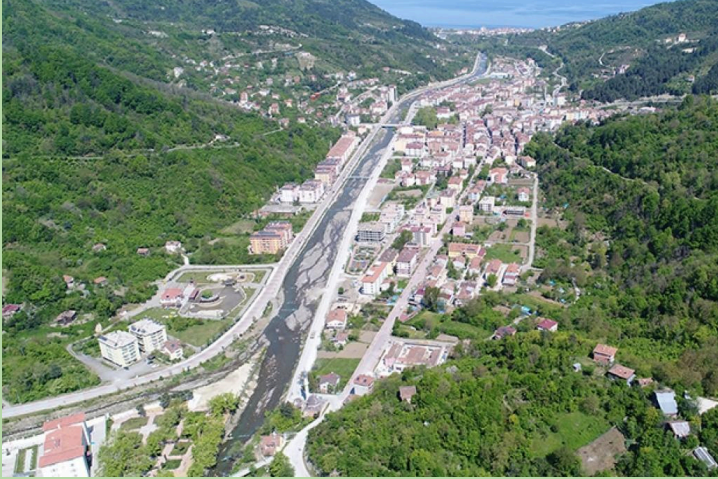
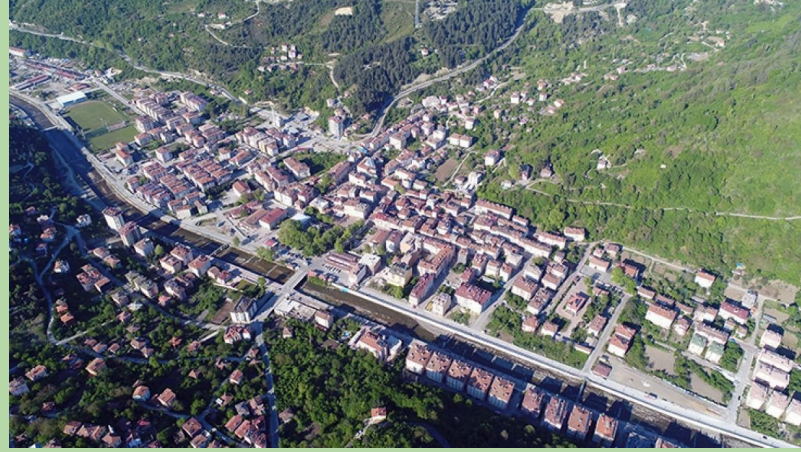
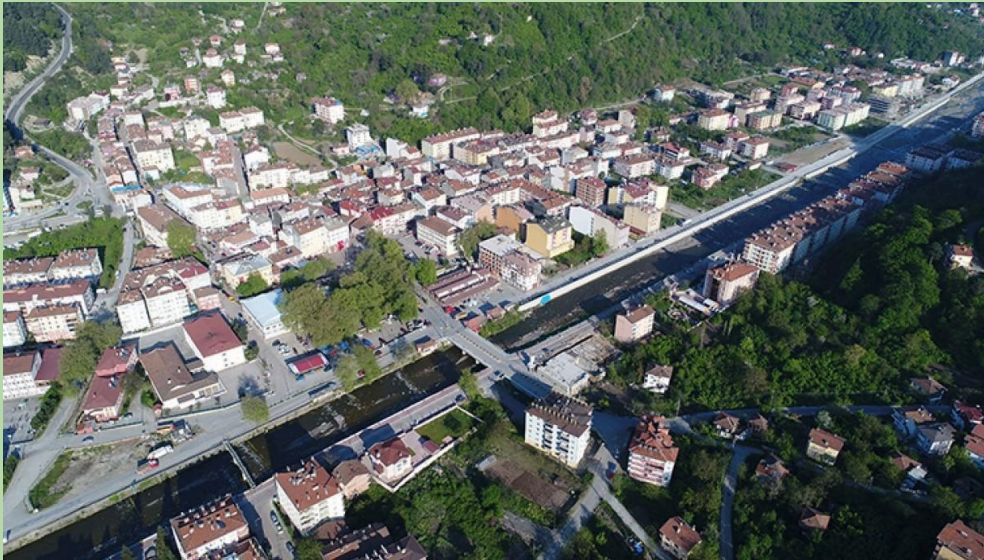
[The condition of Bozkurt district center before the flood event Before the flood, the Ezine Stream follows a regulated channel with relatively stable flow conditions and surrounding urban structures - Source: Bozkurt Municipality]

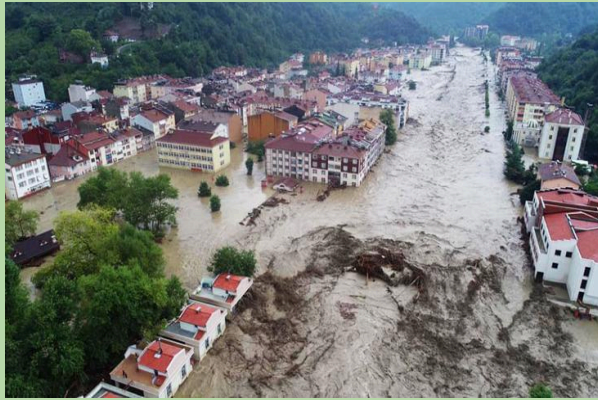
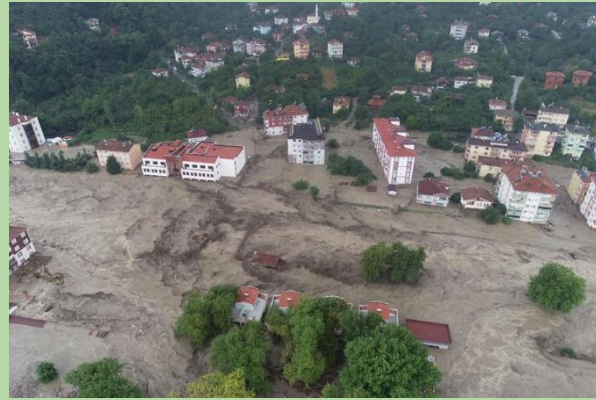
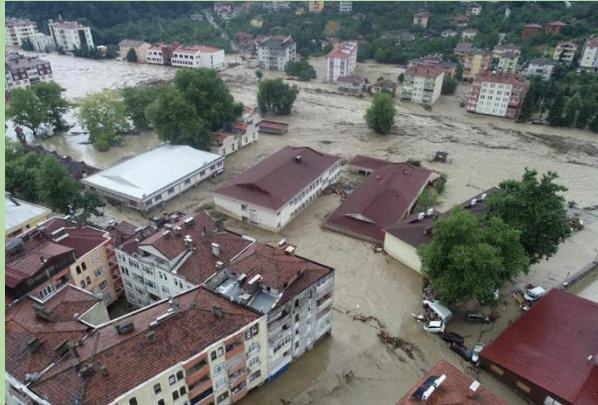
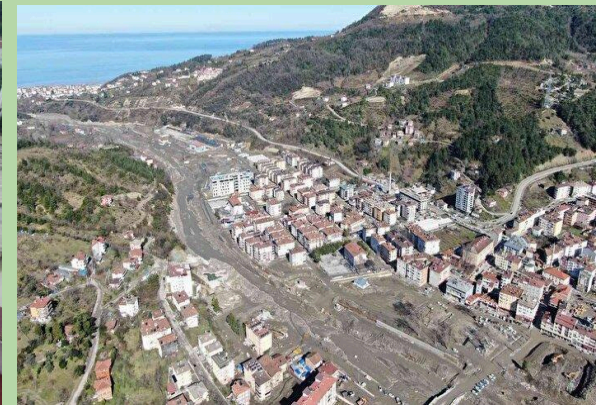
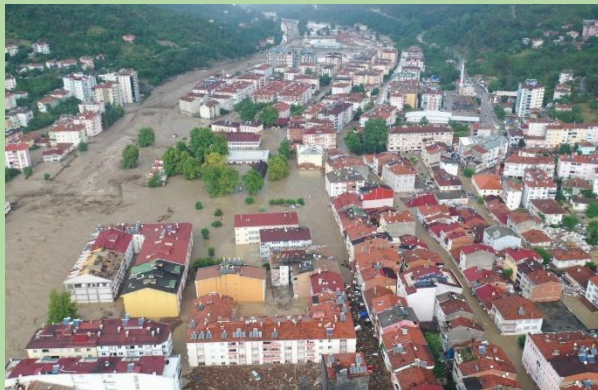
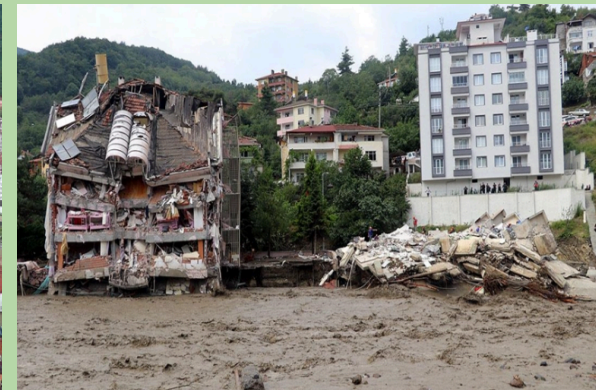
[Flood impacts observed in Bozkurt district following the 11 August 2021 flood disaster. After the flood, the river channel was severely altered due to extreme rainfall, leading to massive sediment transport, channel widening, and extensive damage to residential areas and infrastructure. Significant sediment deposition, destruction of buildings, and expansion of the floodplain are clearly visible - Source: Bozkurt Municipality (2021)]

The Bozkurt–Ezine Stream Watershed, located in Kastamonu Province, West Black Sea Region, Türkiye, experienced a catastrophic flood event in August 2021. Rainfall began around noon on 10 August and continued until midnight, saturating the basin soils. On 11 August, extremely intense rainfall occurred in the upper watershed, exceeding a 500-year return period (133.7 mm/h, with 149.5 mm recorded in three hours). The resulting flood generated severe runoff and sediment transport toward Bozkurt District, causing the loss of **77 lives**, extensive infrastructure damage, and major impacts on settlements. The disaster highlighted the vulnerability of the watershed due to steep slopes, degraded forest areas, erosion, and insufficient flood regulation capacity.

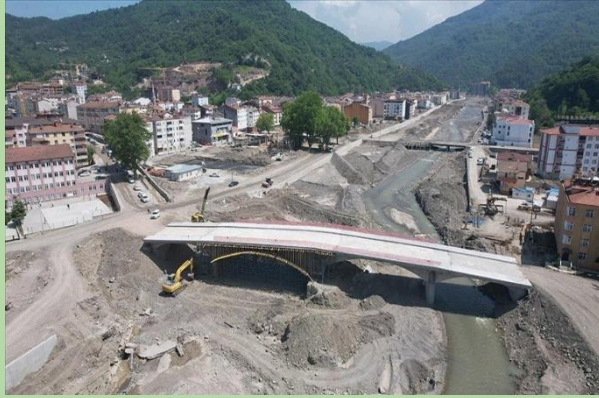
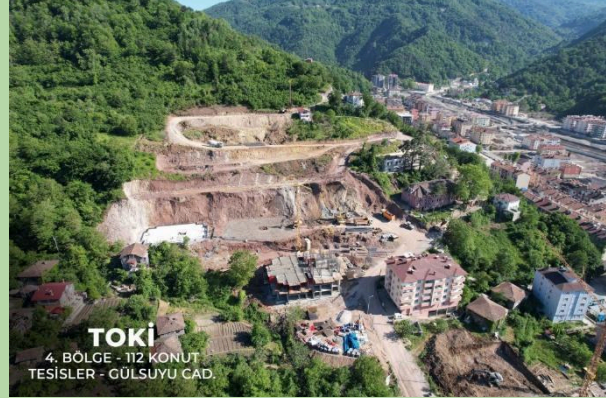
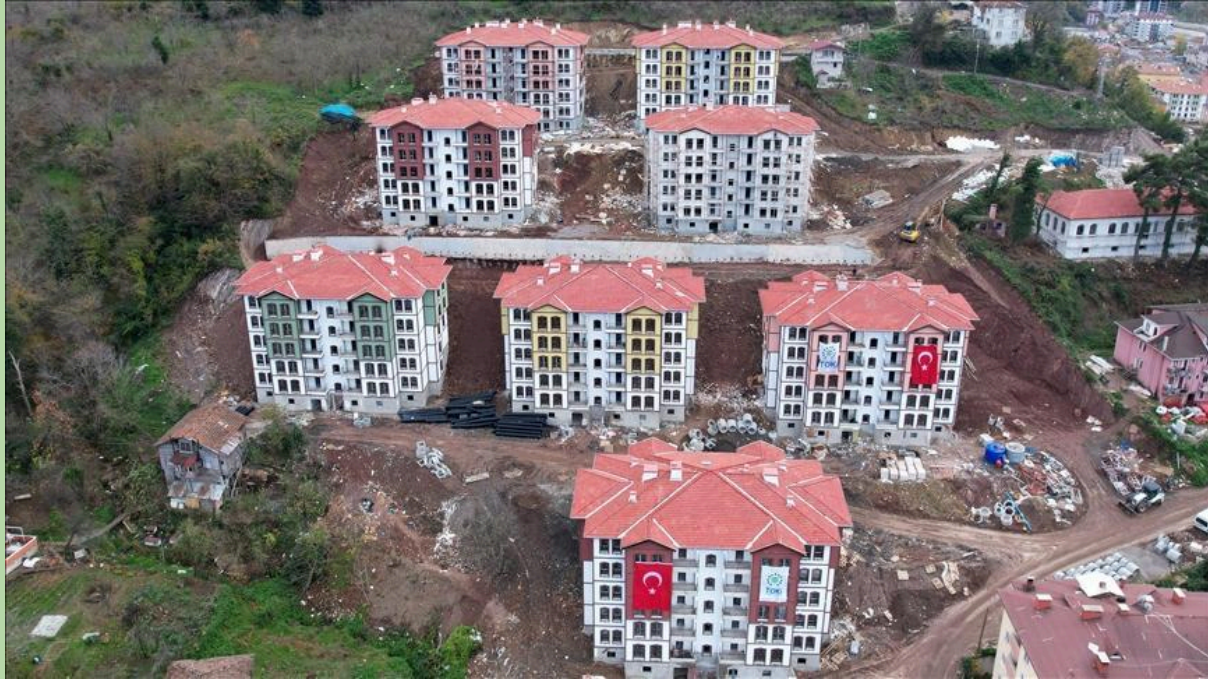
[Post-disaster reconstruction and resettlement efforts in Bozkurt district following the 2021 flood disaster. Following the flood disaster, extensive reconstruction and resettlement activities were carried out in safer areas of the upper basin. New residential buildings were constructed to relocate affected populations, and infrastructure redevelopment was implemented to enhance resilience against future flood risks - Source: Bozkurt Municipality (2022)]

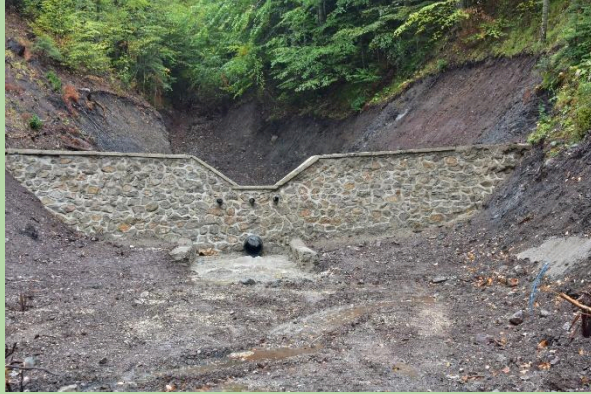
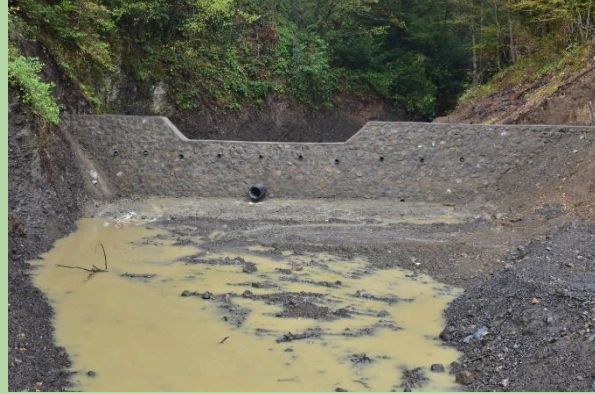
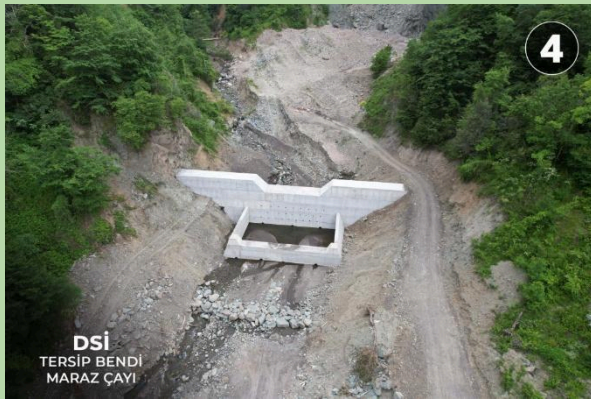
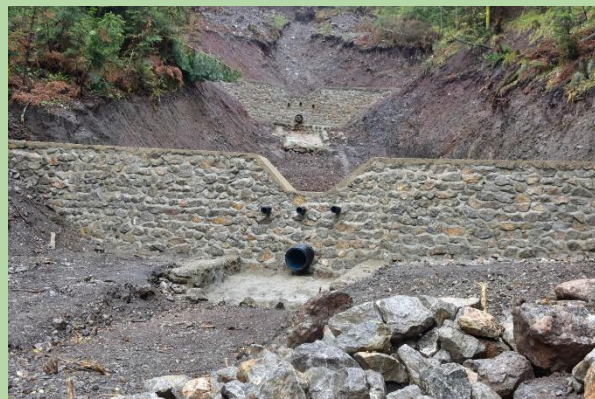
[Structural flood control and sediment retention measures implemented in the upper basin following the 2021 flood disaster. Following the flood event, structural interventions such as check dams, sediment retention basins, and channel stabilization structures were constructed in upstream areas to reduce sediment transport, regulate flow, and mitigate future flood risks. - Source: Bozkurt Municipality (2022)]

The main objective of the project is to eliminate or minimize erosion, soil loss, and damage that may occur as a result of bank erosion, bank collapses, bank slippages in the gully and stream beds within the project area, and shallow landslides affecting the main streams.

Within the scope of the project, transverse structures will be designed in the gully and stream beds within the project area to create toe-like structures on the banks, and the flow regime of spring and rainwater will be regulated to reduce the impact of sediment runoff as floods pass through the basin.
